# Laser-Induced Damage Threshold (LIDT) Measurement Report

## ISO 21254-2: S-on-1 Test Procedure

Sample: 2-CPW-LO-L/2-1030

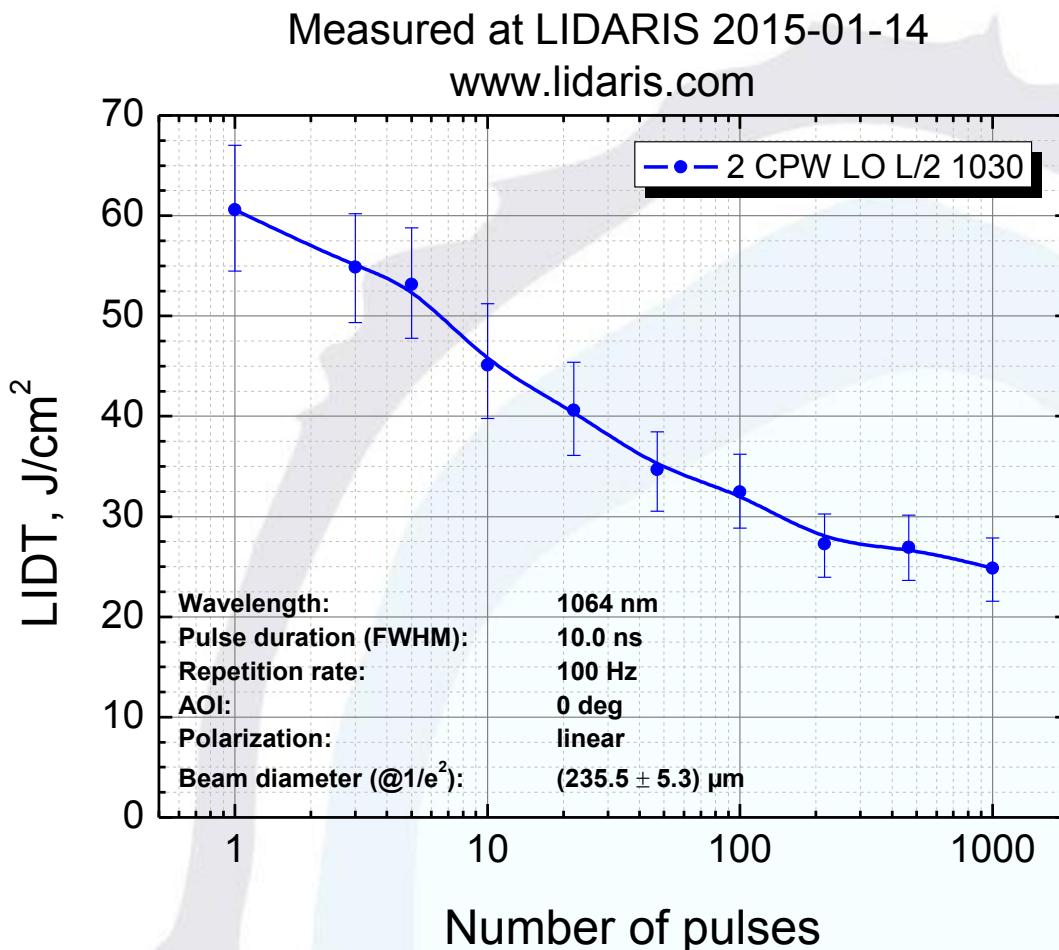
Test mode	Threshold, J/cm <sup>2</sup>
1-on-1	54.50 ≤ 60.59 ≤ 67.01
1000-on-1	21.56 ≤ 24.85 ≤ 27.85

Fig. 2 Characteristic damage curve.

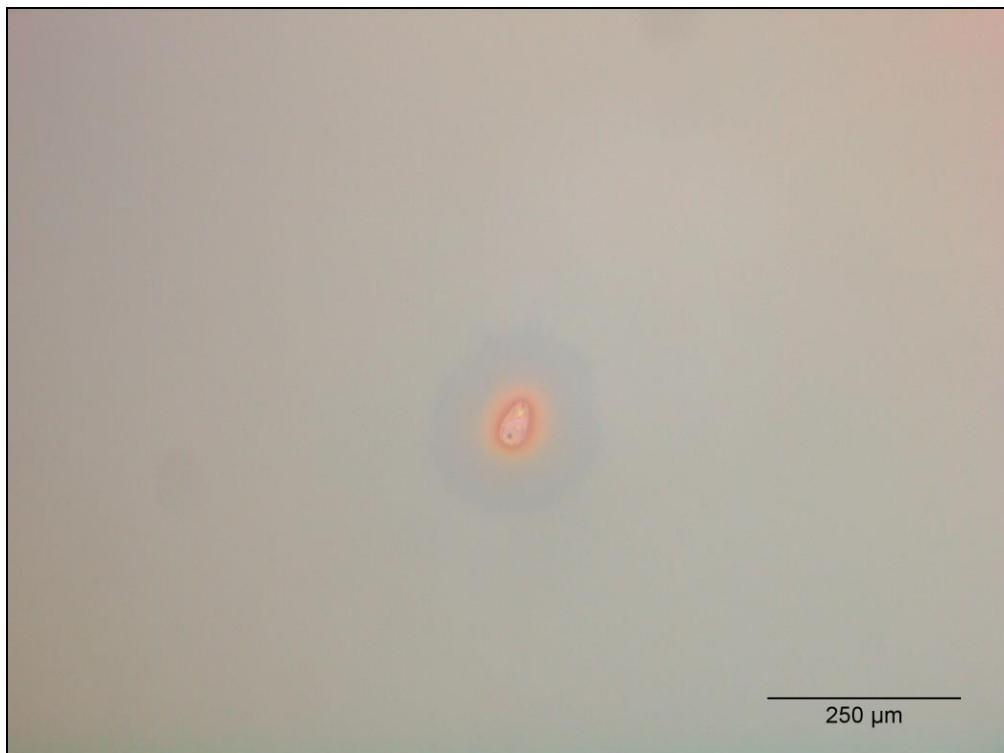
**Fig. 3 Typical in volume damage morphology  
(Energy density 62.39 J/cm<sup>2</sup>, damage after 1 pulse)**

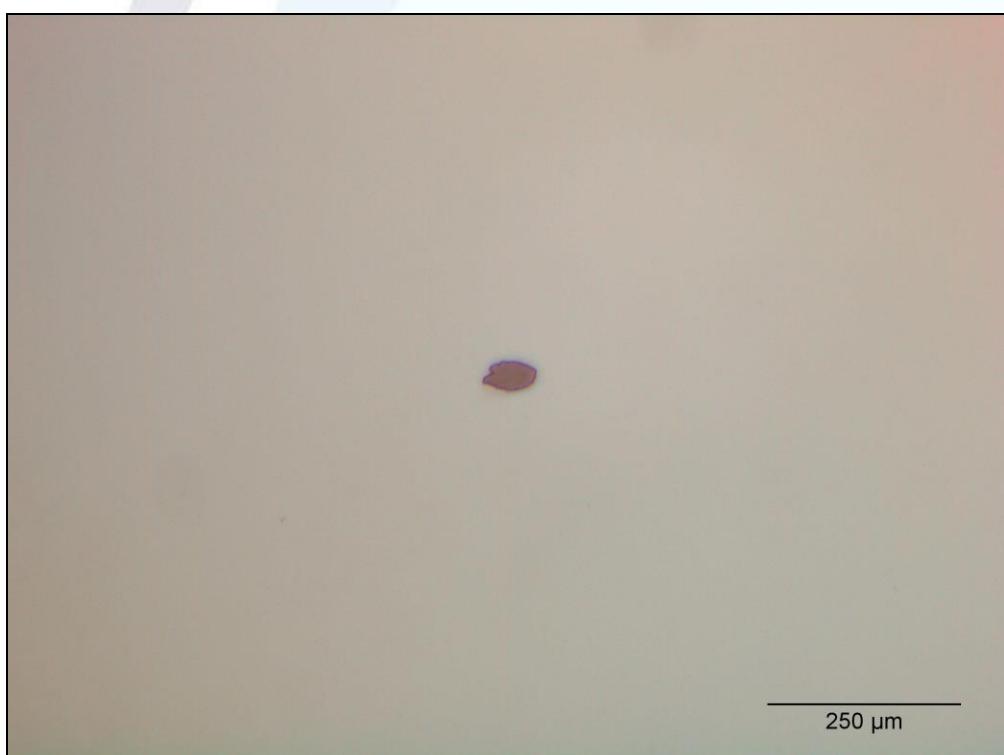
**Fig. 4 Typical front surface damage morphology  
(Energy density 25.98 J/cm<sup>2</sup>, damage after 1000 pulses)**
